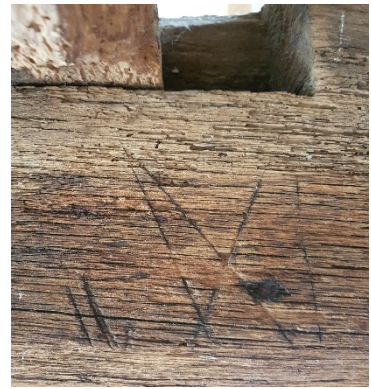
There is also a 'butterfly' mark (below, right) which is apparently a well-known representation of a 'spirit trap' ~ the premise was that any baleful/ malevolent entities entering the house would be drawn to the trap and pinned to the wood and thereby 'neutralised'. These are also known as witches marks.

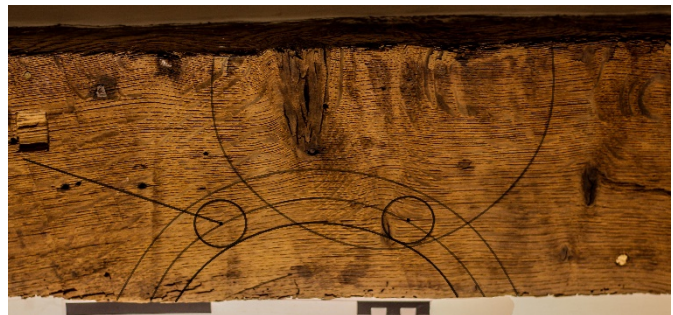
Circles were regarded as solar symbols which could dispel darkness². Those are often interconnected as in this case (right) where there are concentric circles within which are two small circles with another circle overlapping.

12 Pickwick: photograph of circles enhanced by CAD ~ Wiltshire Medieval Graffiti Survey

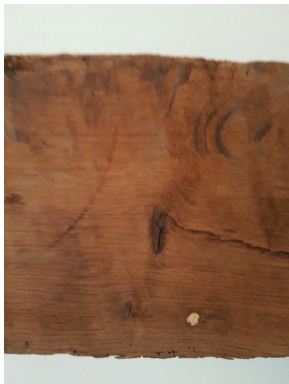
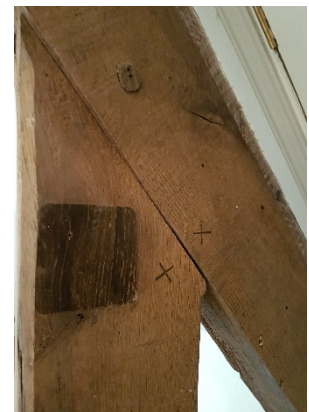
In addition, there is at least one 'candle' burn' mark (left, centre) which were believed to guard against fire or, more generally, evil. Finally, there are medieval carpenters assembly marks which often comprise paired Roman numerals (right, in this instance xx) to indicate which joints fit together.
